# GOLDCORP – AUTOCLAVE SS ENCLOSURE

## Stainless Steel Enclosure installed in 2007

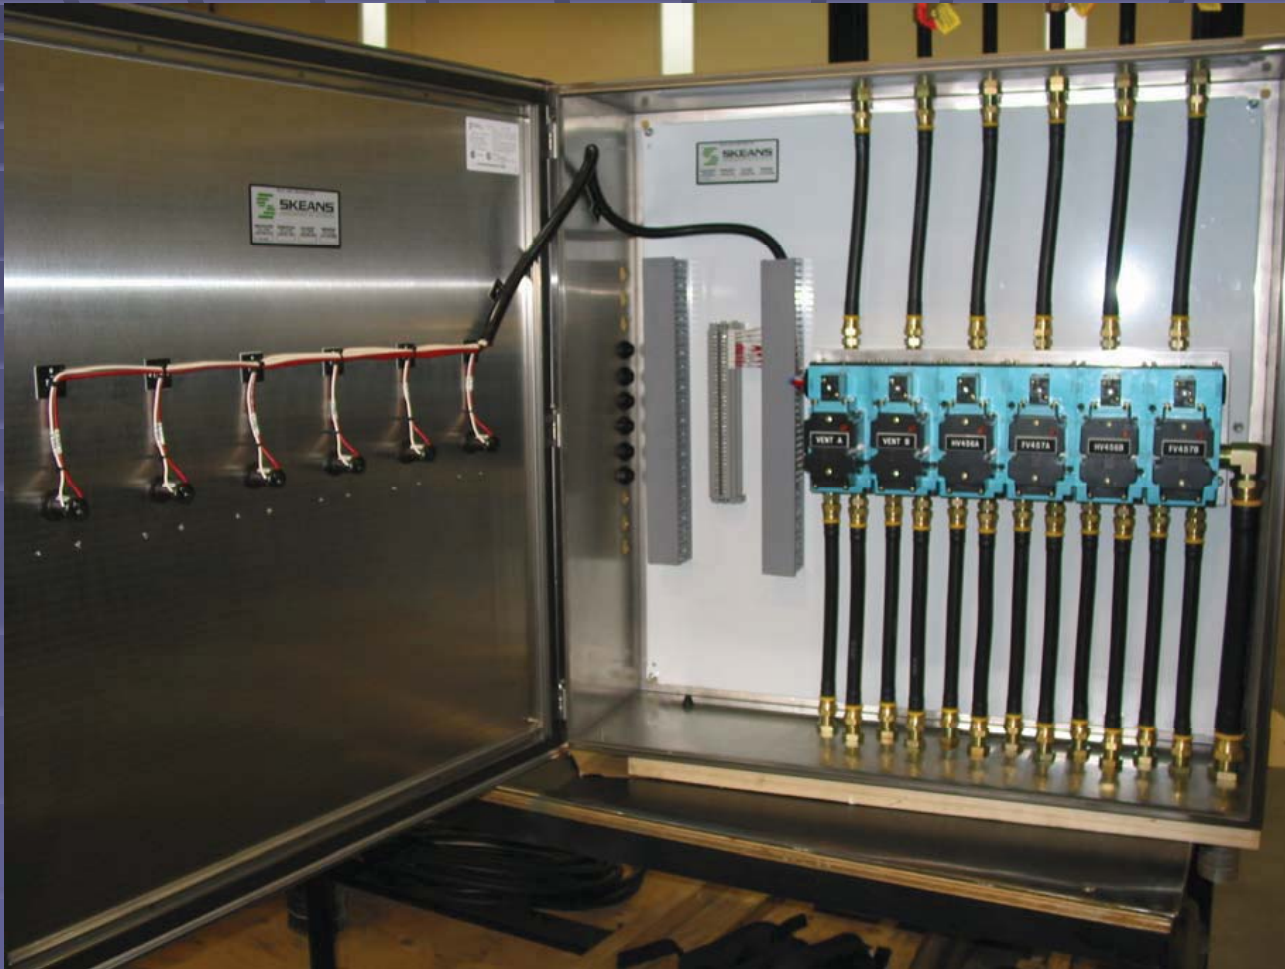
**PROBLEM:** Autoclave environment affected valve life & operation

**SOLUTION:** We packaged a MAC valve bank of 6 on a special manifold with individual inlets into a stainless steel enclosure.

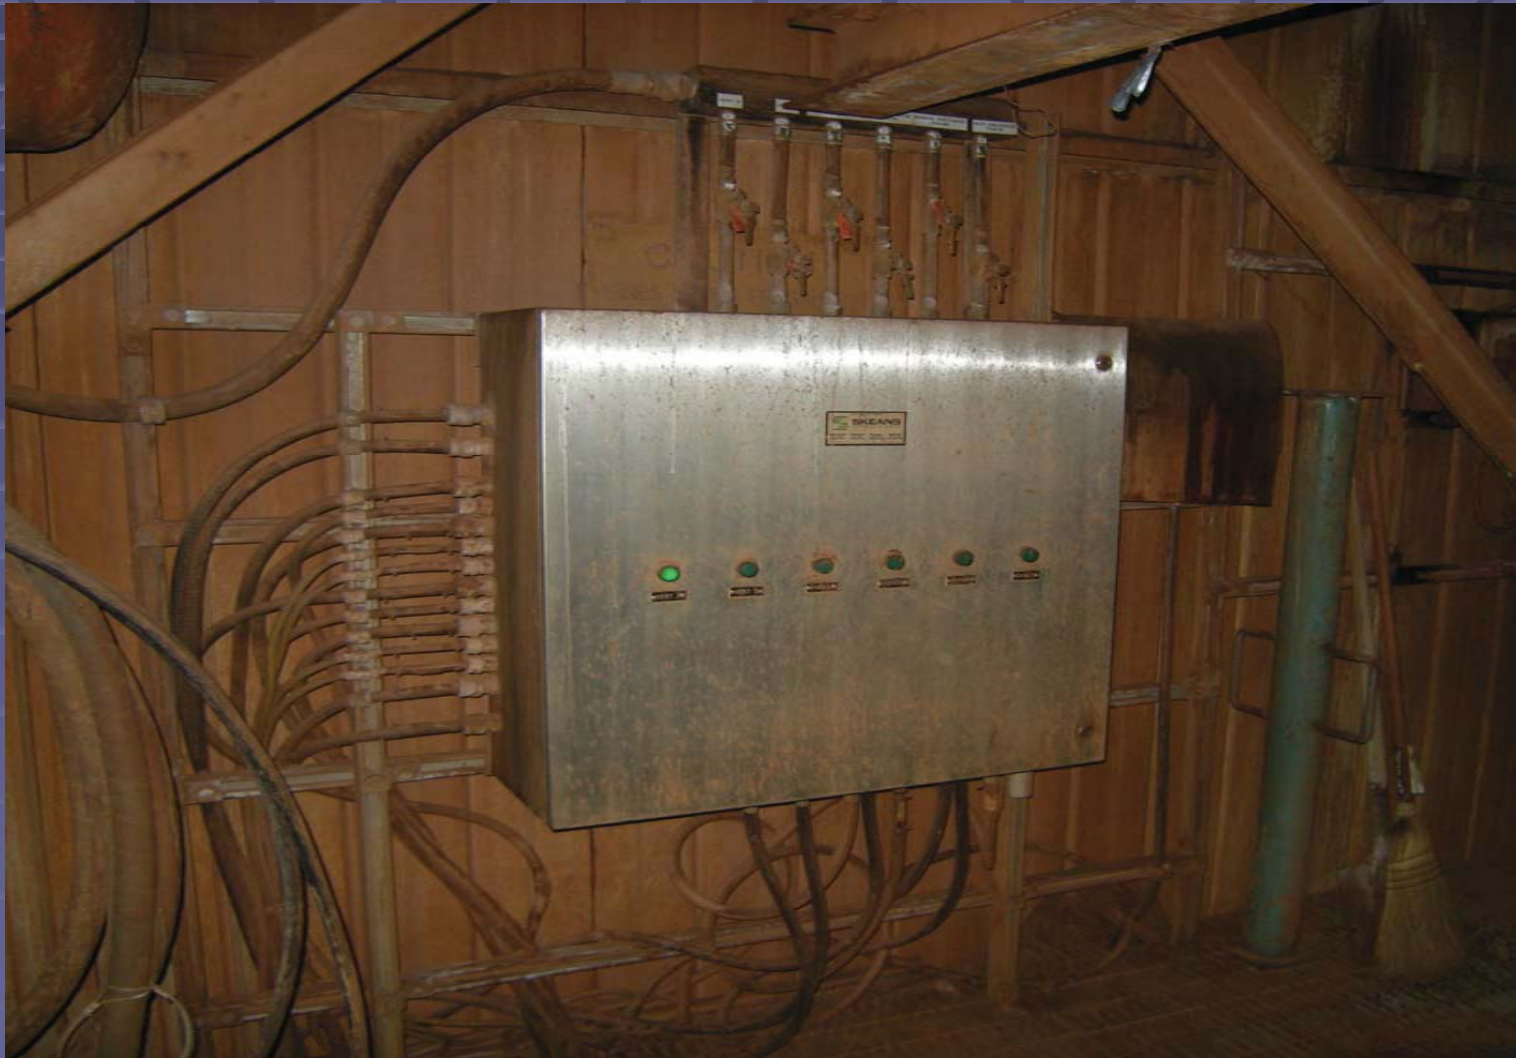
*This is a current 2011 installation picture*

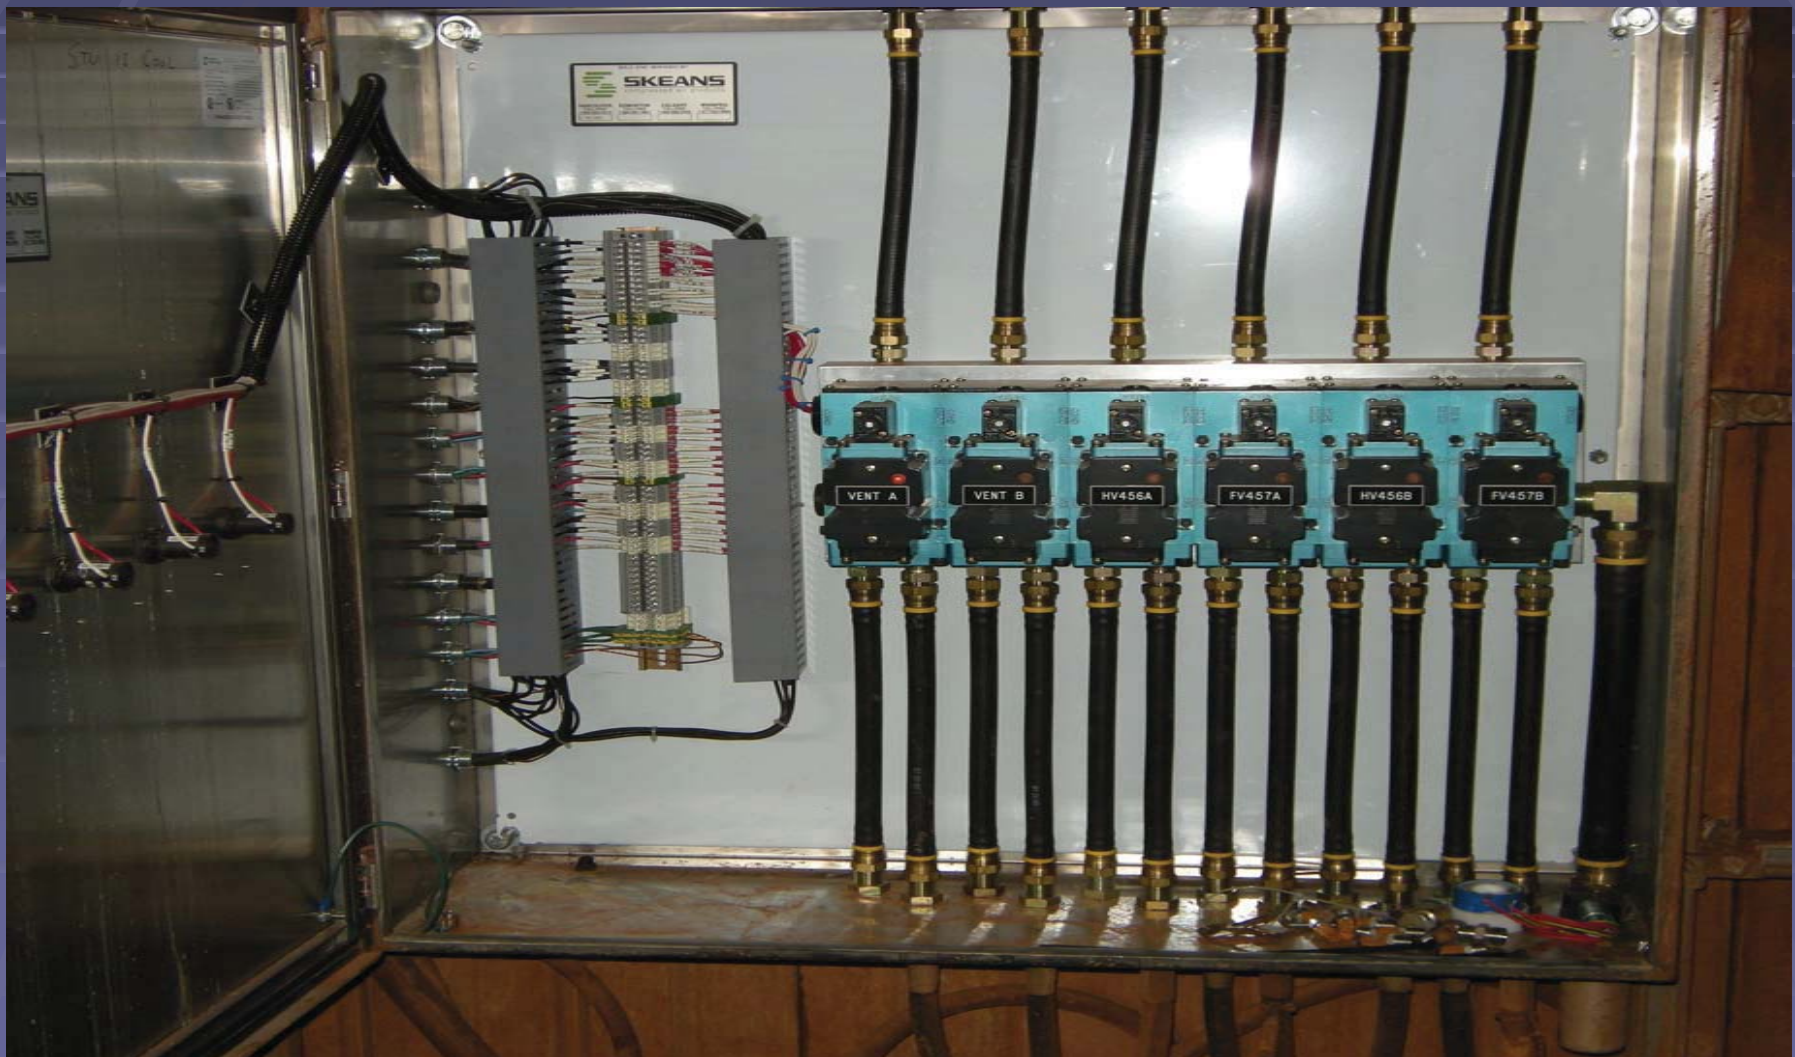
*Current 2011 picture of inside the same  
Stainless Steel Enclosure (4 yrs later)*
